# Environmental Projects: Volume 13

# Underground Storage Tanks: Removal and Replacement

Underground Storage Tanks: Removal and Replacement

Goldstone Deep Space Communications Complex

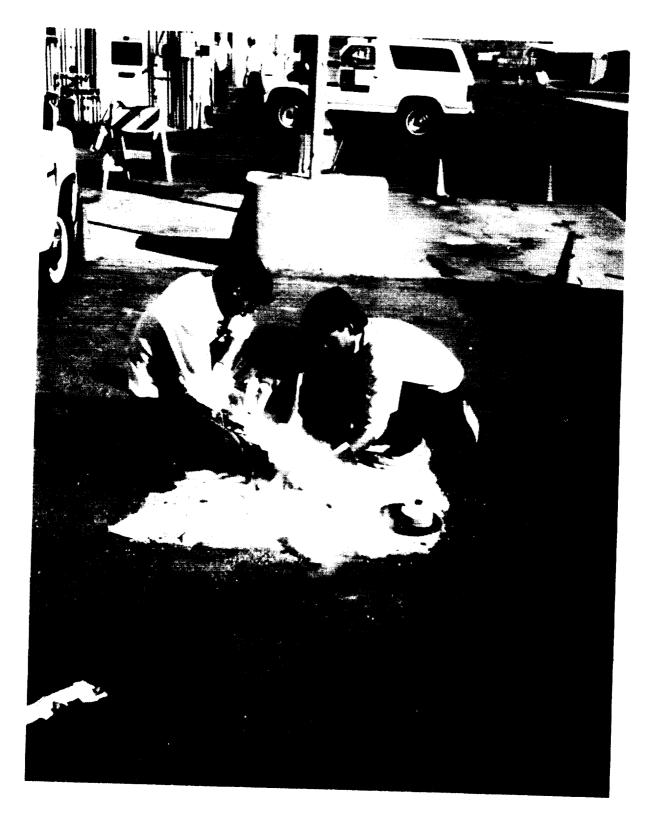
Figure 6. Echo Site: Use of Dry Ice to Inert Tanks G25-1G and G25-2G Before Their Closures

Temporary closure of a tank means that the UST was emptied of its contents and steam cleaned to remove any residual sludge. Fifteen (15) pounds of solid carbon dioxide (Dry Ice) then were placed into the cleaned tank for each 1,000 gallons of the tank's volume to purge the tank's interior of any flammable vapors to levels that precluded any fire or explosion hazard. The use of Dry Ice to inert USTs G25-1G and G25-2G is depicted in Figures 6 and 7. Finally, the UST was sealed with a concrete cap to allow the tank to be disposed of in the future in an environmentally acceptable way.

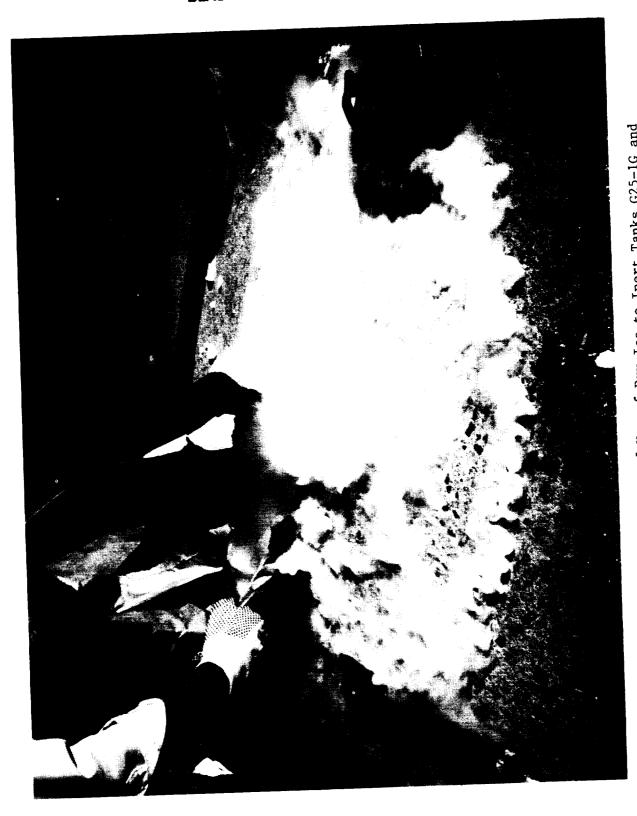
Close-up View of Use of Dry Ice to Inert Tanks G25-1G and G25-2G Before Their Closures Figure 7.

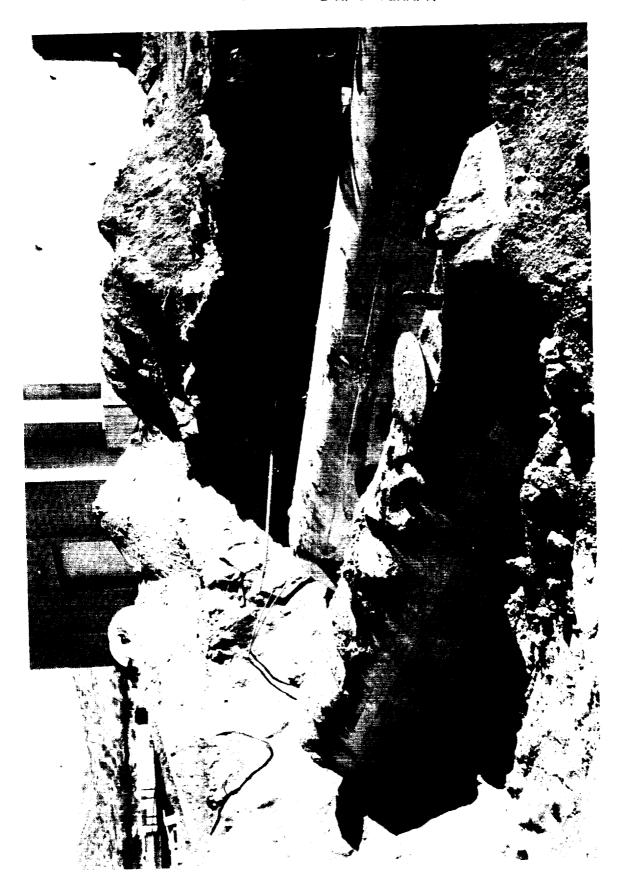
Mars Site: Typical View at the GDSCC of an Excavation to Remove Old UST and Associated Piping Figure 8.

Vent, product, and recirculation lines entering the excavation either were removed or capped at both ends of the piping run. Underground electrical, water, and air lines and all aboveground piping were removed unless a portion of them were to be reused in one of the new tank installations. Pumps, pump islands, old concrete, and asphalt were removed from the excavation area. These materials, along with any removed piping, were transported to the GDSCC on-site solid waste disposal facility at the Echo Site.

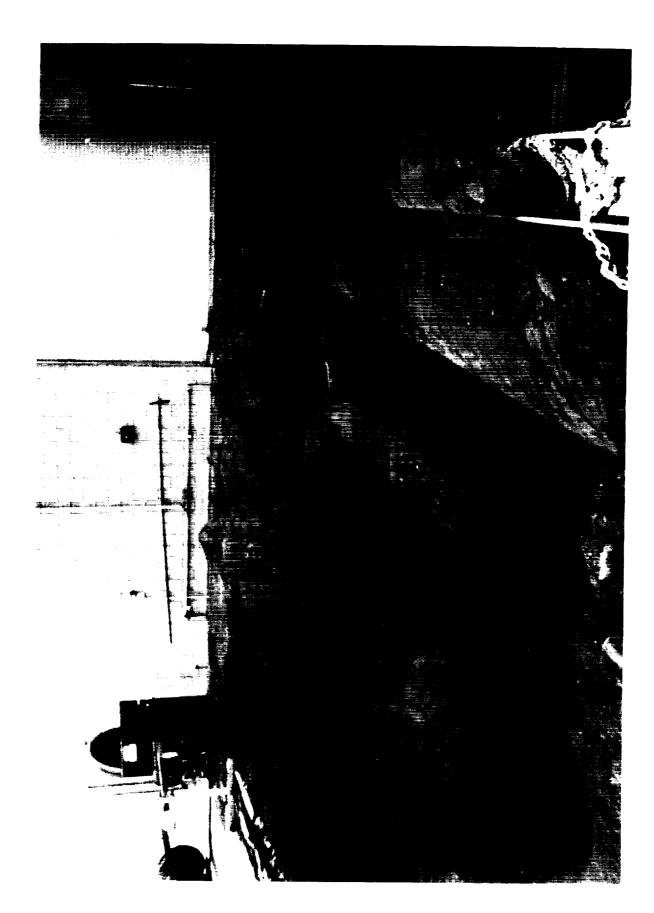
Echo Site: Excavation to Remove Two Old Diesel USTs near Bldg.  $\mathsf{G24}_{\cdot}$  the Generator Bldg. Figure 14.

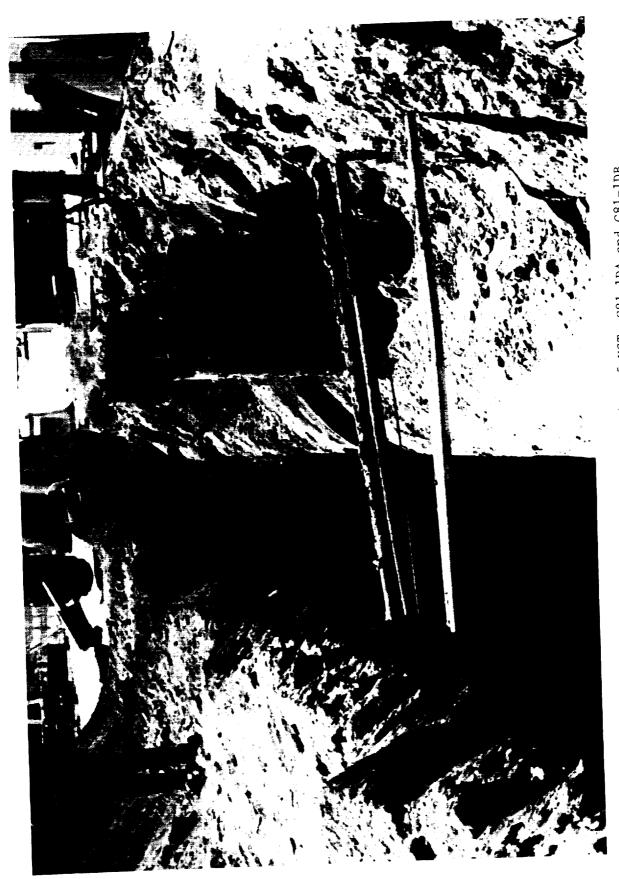
Mars Site: Partial Excavation of USTs G81-1DA and G81-1DB Adjacent to Generator Building G81 Figure 18.

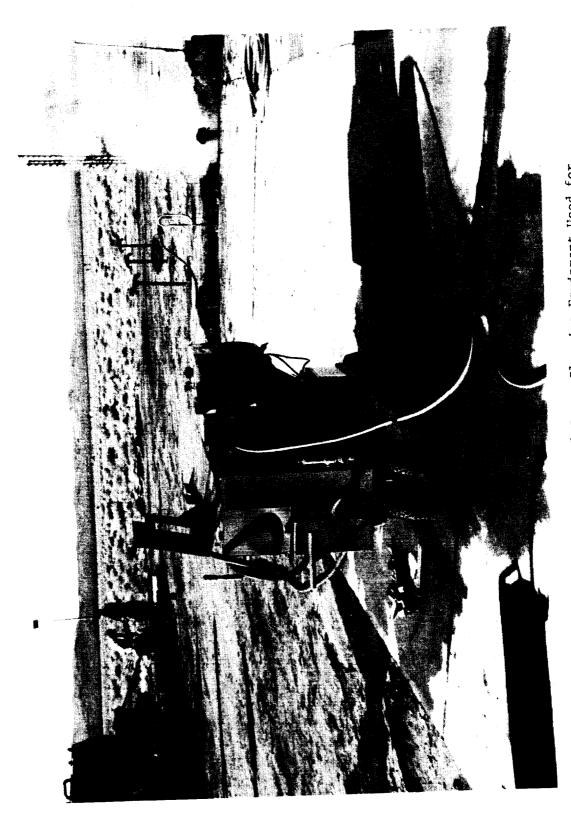
Apollo Site: Typical Steam Cleaning Equipment Used for Cleaning of Tank Before Tank is Inerted and Sealed Figure 26.

The cleaning of the USTs at the GDSCC and the testing for any residual explosive gases remaining with a GX3 Gas & Oxygen Monitor, was carried out by Cleaning and Pumping Specialists, Inc., Signal Hill, California, 90806. The Cleaning records for all USTs and the calibration of the GX3 Gas & Oxygen Monitor are presented in Appendix B.

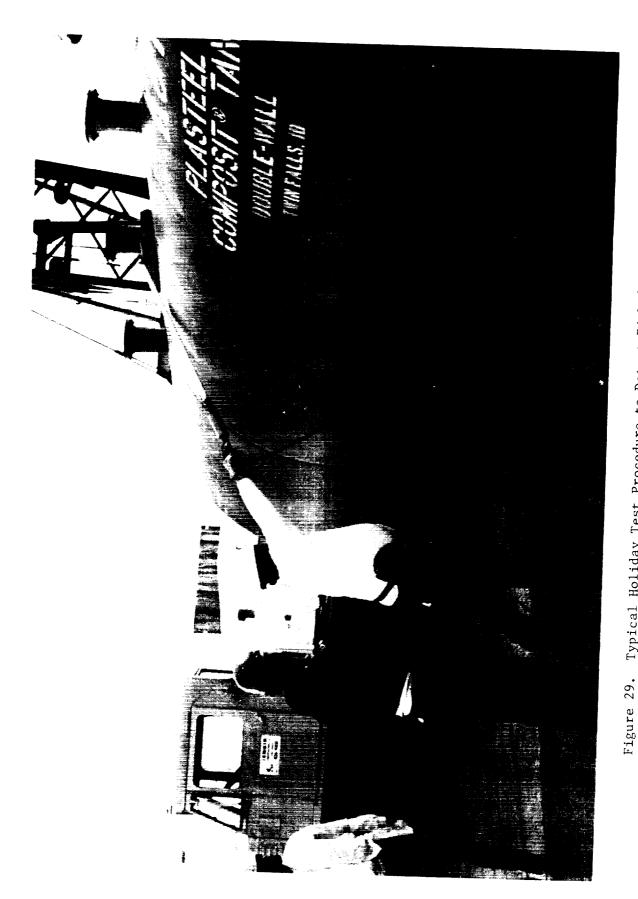
Typical Holiday Test Procedure to Detect Pinholes in Outer Fiberglass Coat Before UST is Interred

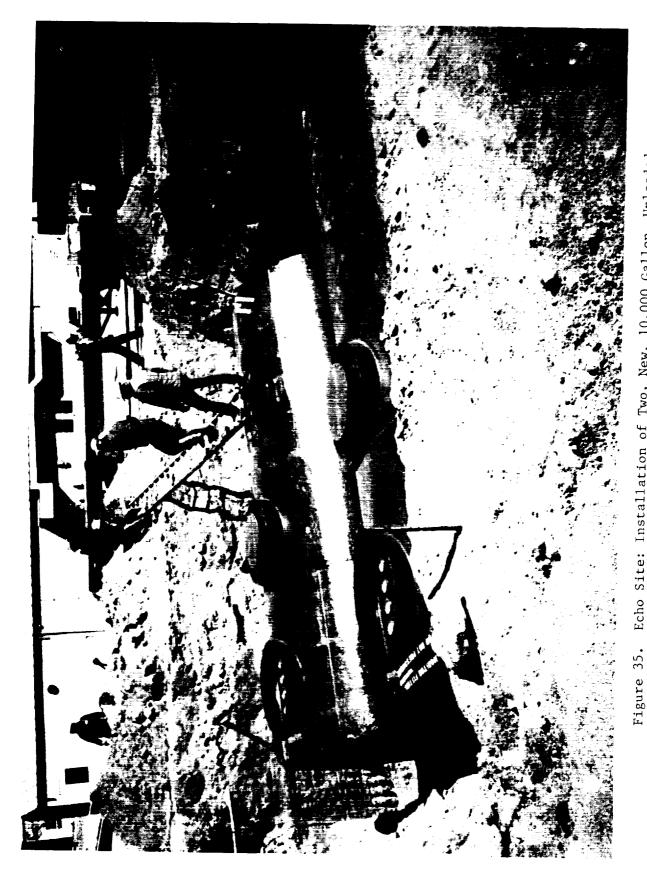
Echo Site: Installation of Two, New, 10,000 Gallon, Unleaded Gasoline Tanks at GSA/FDS No. 1

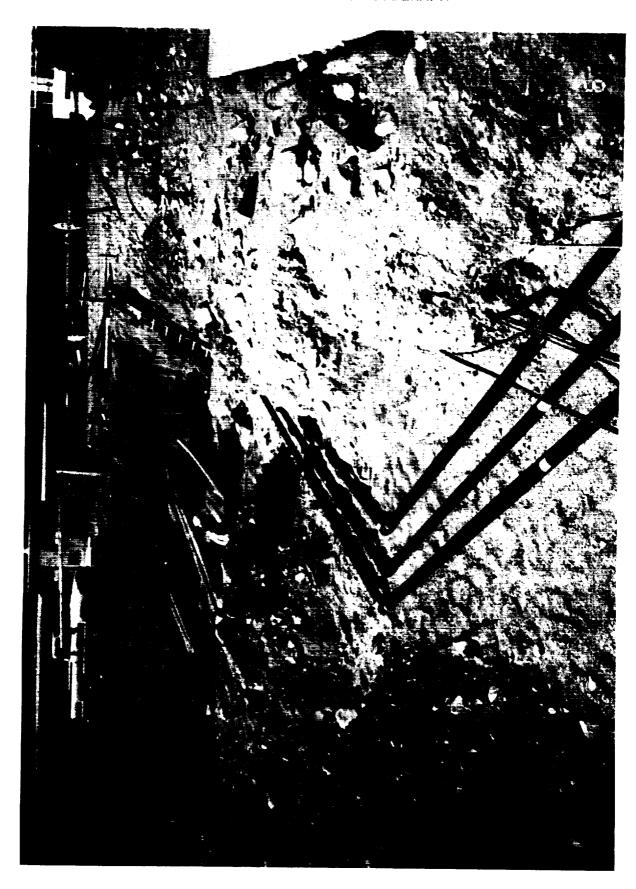
Mars Site: Typical View of New Double-Walled Piping Leading From New USTs G81-1D and G81-2D to G81, Generator Building Figure 40.

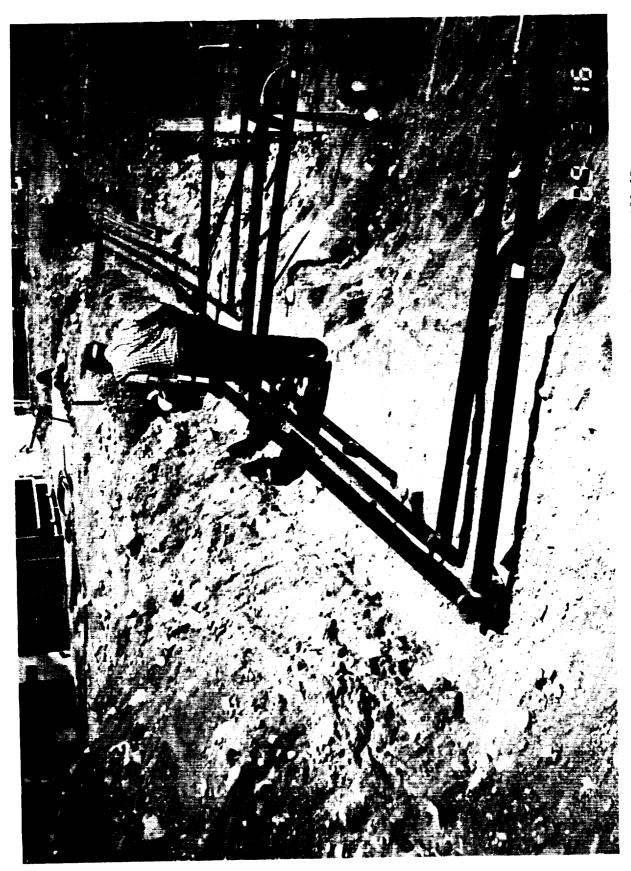
Mars Site: New Double-Walled Piping Leading from USTs G81-1D and G81-2D to Bldg. G81 Figure 41.
